**Case studies into the Performance and Benefits of Advanced Ceramic Coating Technologies for Corrosion, Erosion and Slagging Mitigation in Fossil Fuel Fired Power Generation Units.**

Antonio Liberatore  
Furnace Mineral Products Inc.  
37 Sandiford Drive, Suite 209  
Stouffville, ON L4A 7X5  
Canada

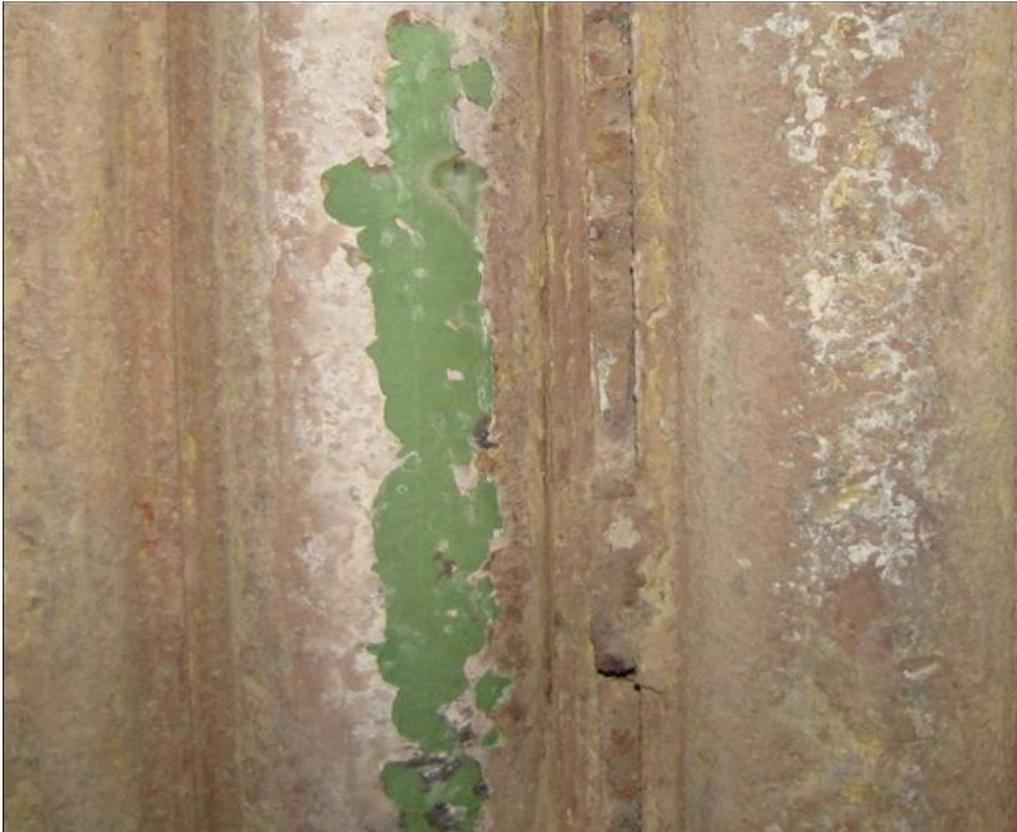
General observation of the surface condition protected by ceramic coating on furnace waterwalls exhibited slight uniform film deposition with no sintering to the tube surface or heavy agglomeration. Slag deposition on the ceramic coating surface exhibited varying degrees of tightness and bond strength. In most areas, the deposit was easily removed from the coating by wiping the surface with a rag. In other areas tapping the slag with a hammer removed the deposit film and revealed the underlying ceramic coating. (Figure 2)

**Figure 2: Thin slag deposit removed revealing intact ceramic coating in lower furnace**

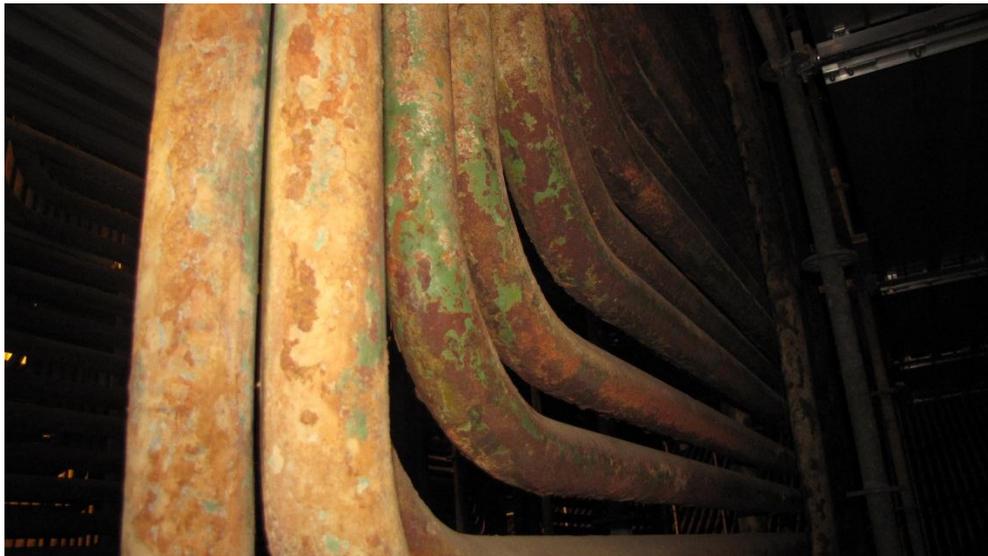
Slag agglomeration on ceramic coated superheater tubes was generally patchy and very loosely adhered. (Figure 3)

**Figure 3: Patches of loosely adhered slag on coated superheater element is as found condition**

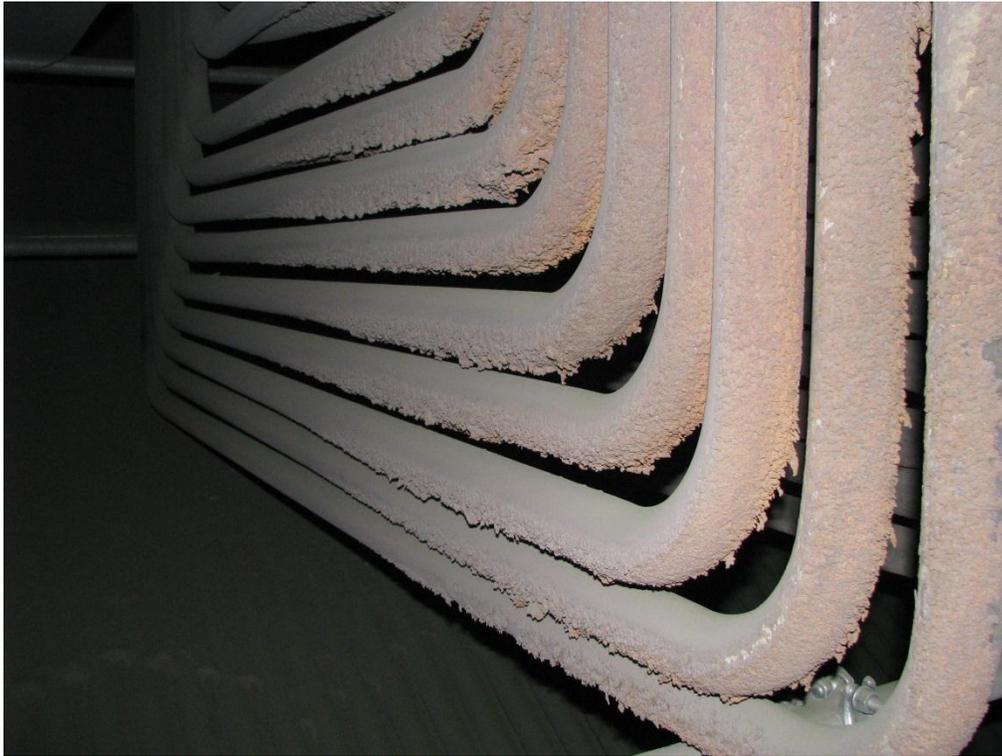
Areas in the superheat section unprotected by ceramic coating revealed a thick slag agglomeration with complete slag agglomeration between the tubes in some areas. (Figure 4)

**Figure 4: Heavy, well adhered slag on uncoated superheater element**

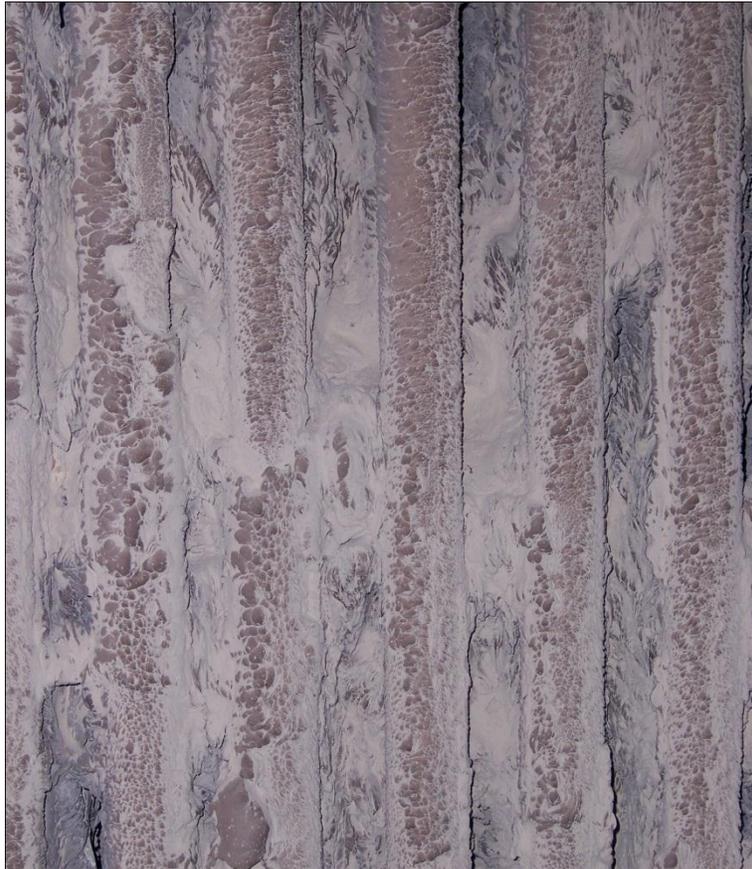
The superheat sections of each boiler become plugged with sulfated limestone agglomeration up to the point that the units had to be brought off line.

Under normal operating conditions with clean superheater sections, the pressure differential (dP) would average 1.75" H<sub>2</sub>O (inches of water column). As the superheater sections became plugged, average dP across the sections would approach 8" H<sub>2</sub>O, at which point the unit would be shut down in order to remove the agglomeration. Forced outages related to plugging were occurring 1 to 2 times per year.

**Figure 5: Plugged section of superheater prior to cleaning and ceramic coating application**

Prior to the initial application of the ceramic coating, the heavily plugged sections of superheaters (Figure 5) were cleaned and the bare tube surface prepared for the application. Figure 6 depicts a cleaned section of superheater. Ceramic coating was applied to 100% of the tubes in both superheaters. (Figure 7)

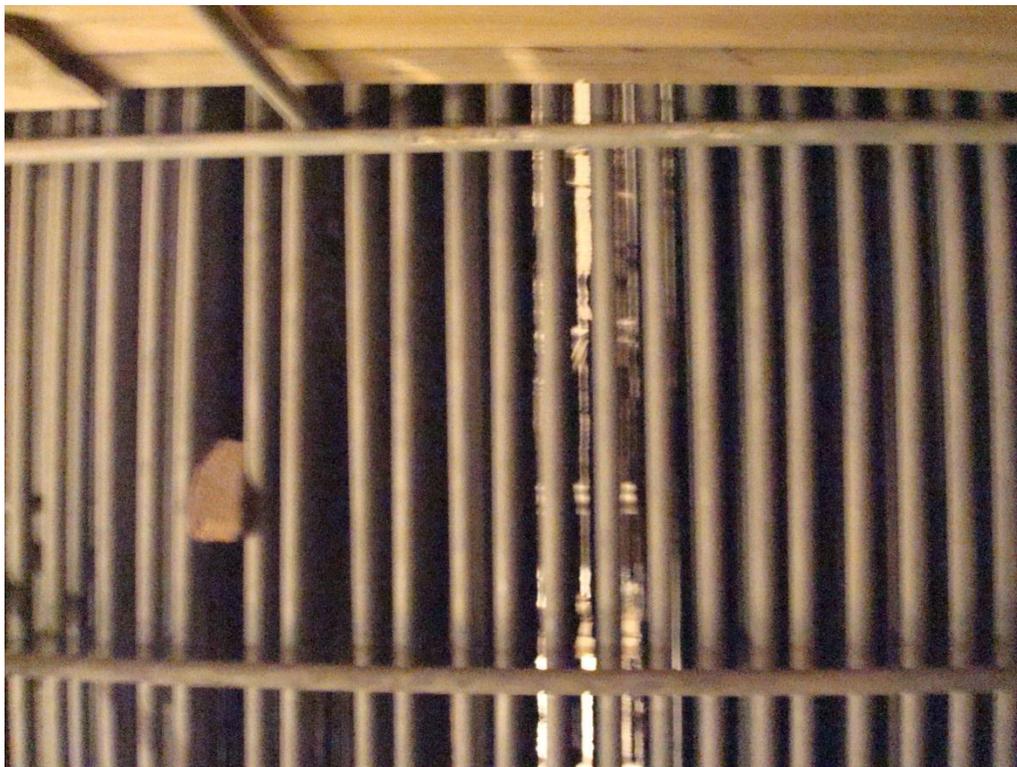
**Figure 6: Section of superheater at the completion of cleaning**

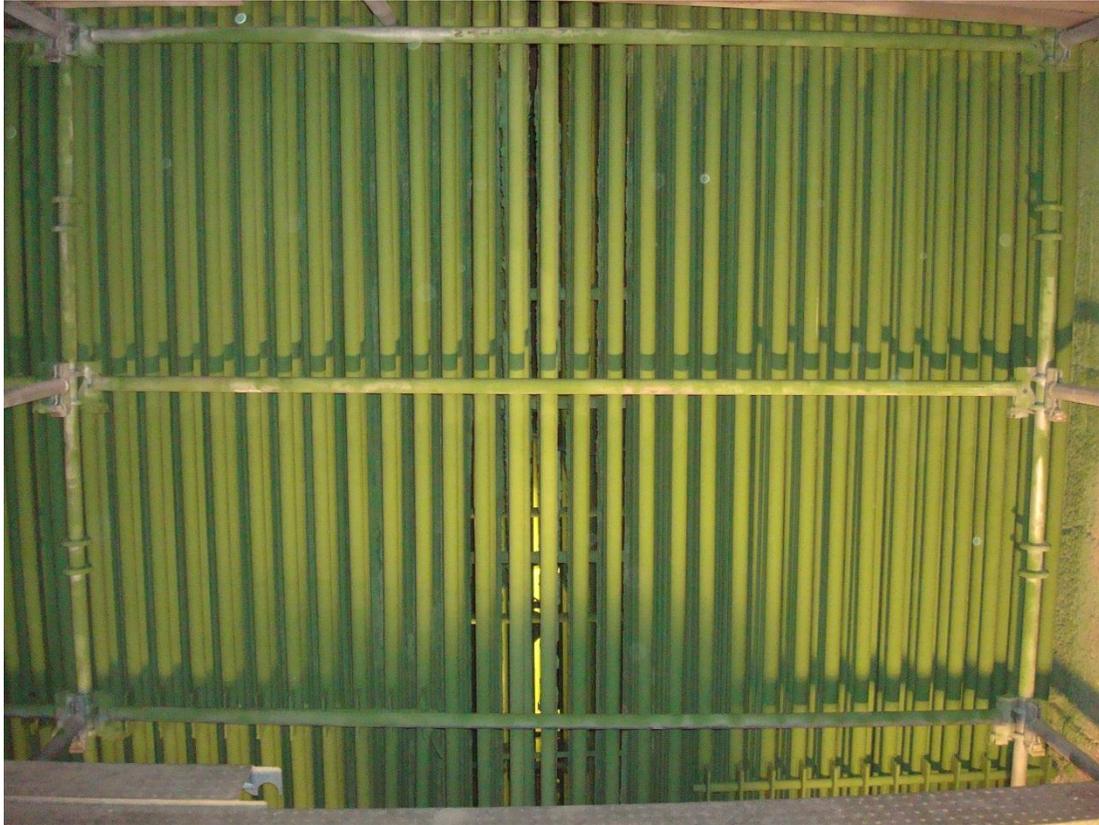
**Figure 7: Superheater section at the completion of ceramic coating application**

The plant was eager to find methods to reduce the frequency of forced outages. Ceramic coatings were applied to the tubes in the superheater sections to inhibit the initial sintering that leads to agglomeration.

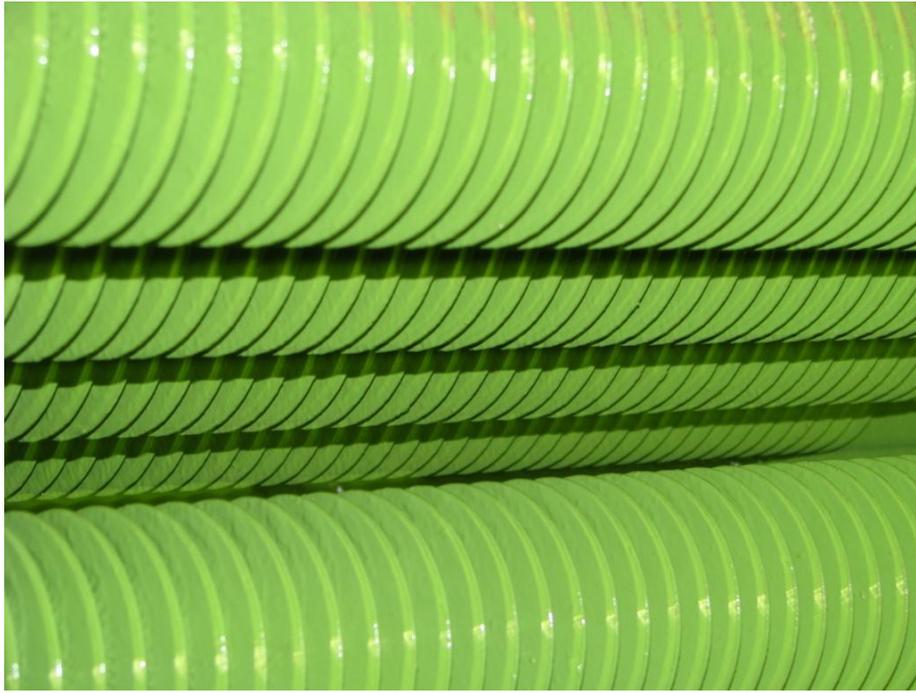
**Figure 10: Coated finned tube economizer bundle**

Ceramic Coating was successfully applied to the economizer bundle to a nominal thickness of 200  $\mu\text{m}$  (8 mils) during the fall of 2008. Figure 10 below shows a section of the coated economizer.

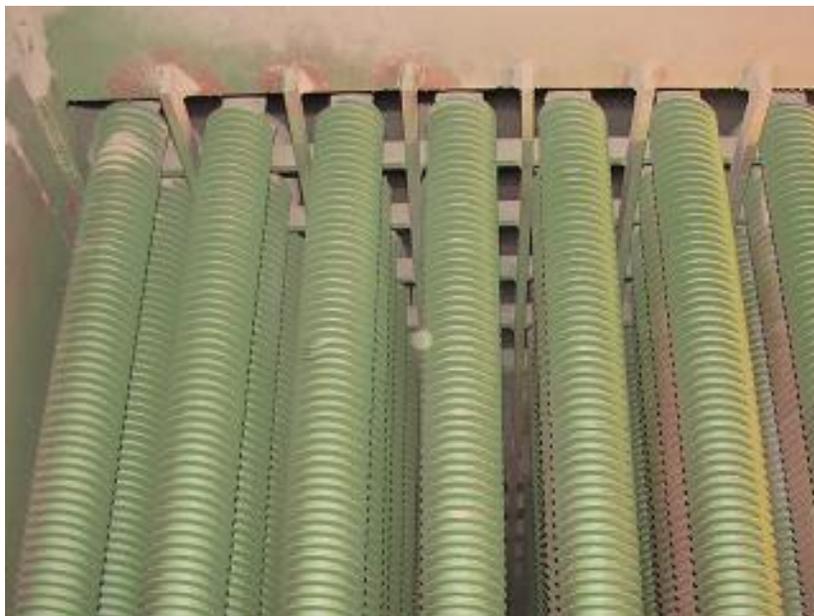
The erosive environment had resulted in an average coating thickness loss of 25  $\mu\text{m}$  (1 mil) over the 12 month period. (Figure 11) Visual inspection of the coating indicated that there was no degradation of the coating material.

There have been no instances of tube leaks in the economizer since the initial application of the ceramic coating.

**Figure 11: Coated economizer after 12 months continuous service**
