Ceramic Coating Surface Protection Solutions for Biomass and Coal Fired Power Generation Boilers

Antonio Liberatore, P.Eng
Furnace Mineral Products Inc.
7065 Tranmere Dr, Ste 6
Mississauga, ON L5S 1M2 Canada

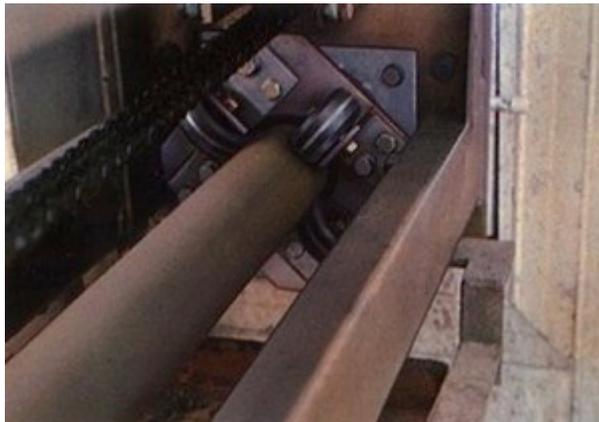
Waterwall soot blower, Photo Seelen GmbH

With all types of coal or solid fuel used in power generating boilers, a certain amount of slag is expected. The amount of slag is controlled by using effective soot blowers. These blowers enter the boiler through a small furnace wall opening and rotate directing a jet of media at the slag to loosen and knock it off the tubes.

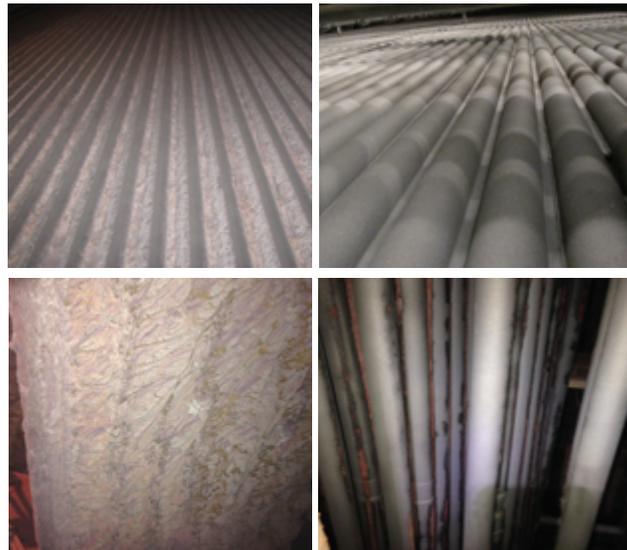
Dry abrasive blasting to remove slag build up from boiler tube surface

For extended run operation full boiler abrasive blasting cleaning is one of the most effective cleaning techniques. This cleaning results in a very low differential pressure and lower flue gas temperatures with improved heat transfer. Dry abrasive blasting or vapour blasting also limits the amount of water that is used as part of the cleaning technique. The introduction of water can lead to generalized corrosion in the boiler.

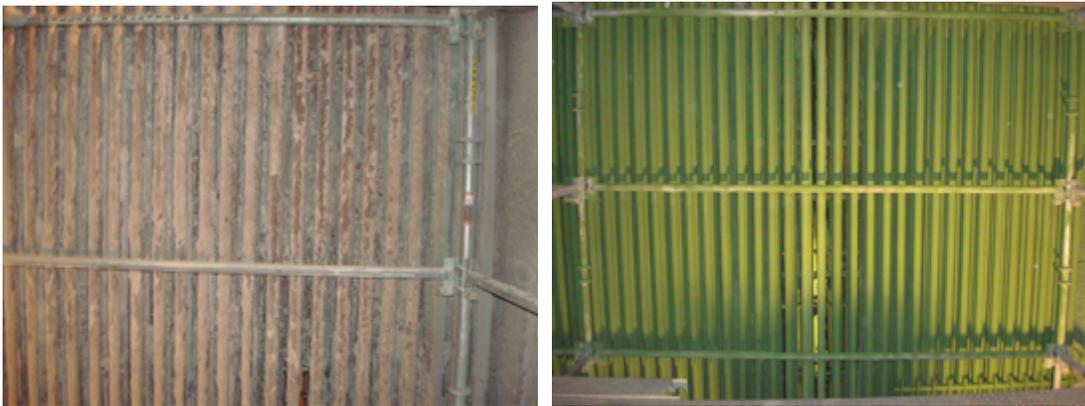
a. Complete blockage of superheater tubes. b. Application of ceramic coating to extend boiler uptime by reducing forced cleaning outages.

Excessive slagging in tightly spaced tube bundles can quickly result in flue gas stream blockage. As slag begins to bridge it reduces the cross sectional area for flue gas to flow through the tube bundle. As the blockages grow, the flue gas velocity increases. Blockages between tubes like in the case of a generating bank has the effect of forcing the gas flow into smaller open passage ways in the tube banks. These open passage ways, are exposed to an increased velocity and higher temperatures due to a reduction in heat transfer from the slag insulating the tubes. This can indirectly contribute to aggressive localized tube erosion and an increase in slag build up in the next section of the convection pass.

The use of ceramic coating technology as an effective barrier to limit slag adhesion on contact with the coating has a proven track record in extending a boiler run time especially in areas that are difficult to clean by soot blowing. When used in conjunction with soot blowing, ceramic coatings can enhance the cleaning action and allow the soot blower to operate less frequently and with shorter durations as the slag is easily removed from the coated tube surface.

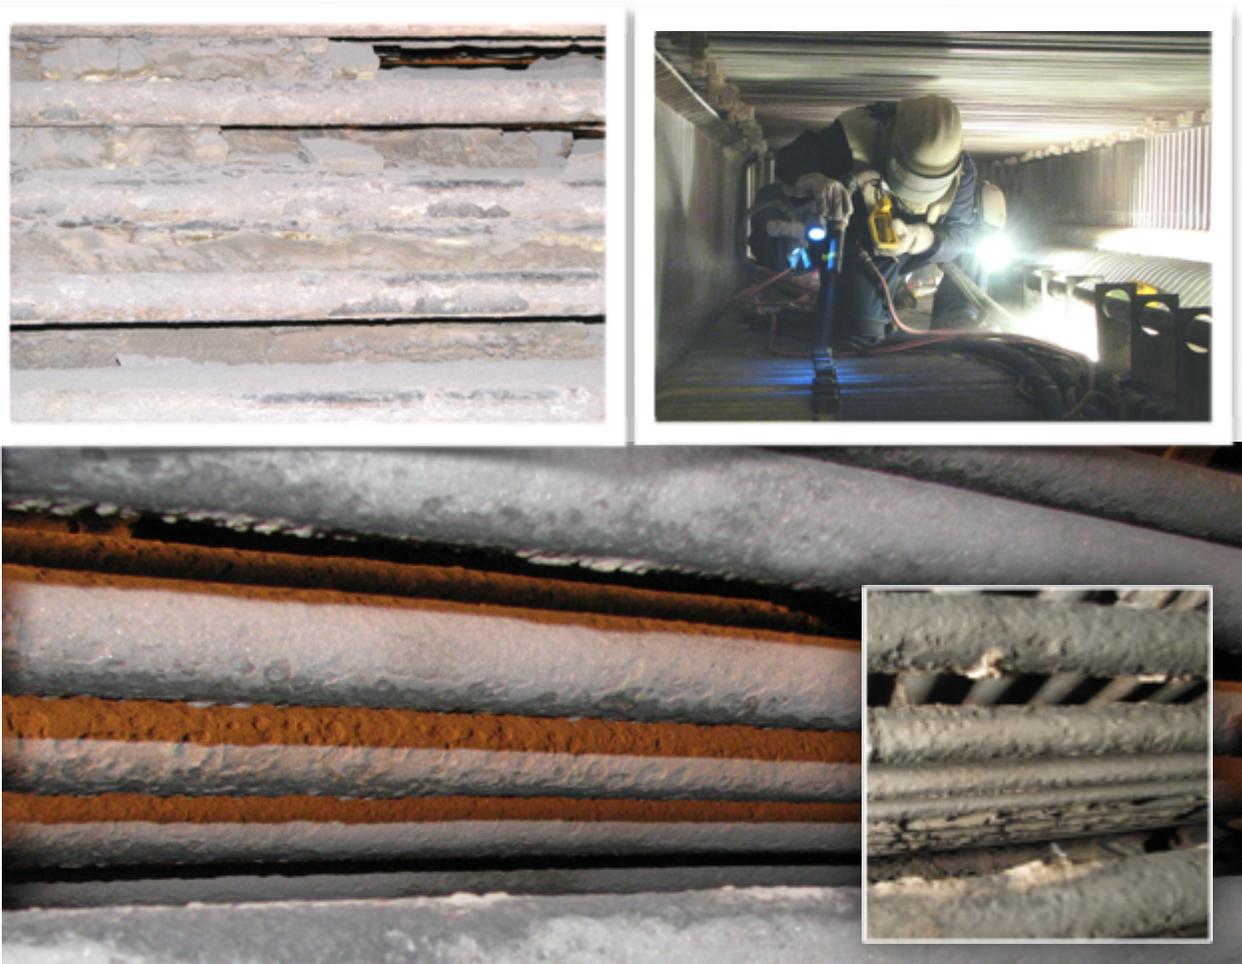
Deep pitting observed in biomass boiler superheater tubes after abrasive blasting to remove slag deposit.
 Photo by Furnace Mineral Products Inc.

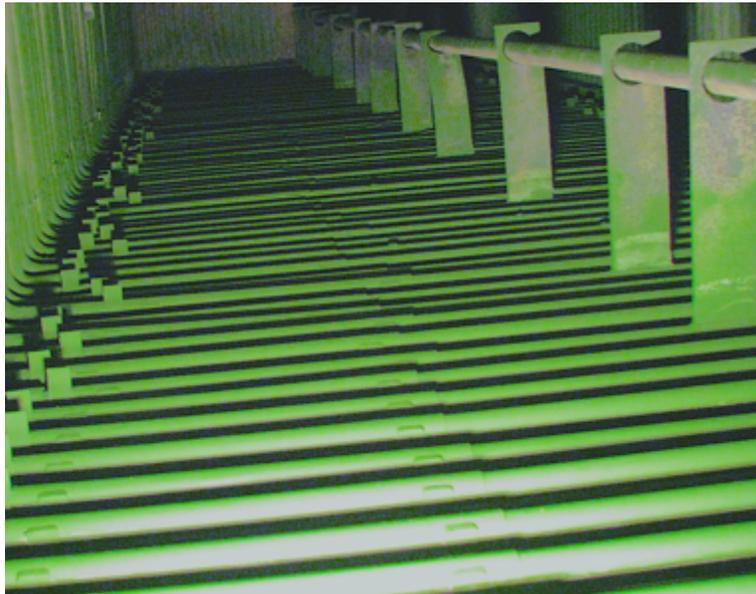
Installation of ceramic coating technology designed specifically for corrosion resistance, Photo by Furnace Mineral Products Inc.

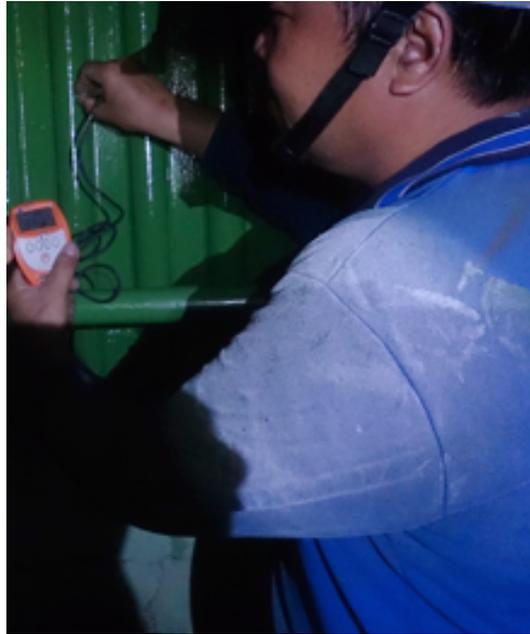
Quality control testing following the application of ceramic coating in a pulp and paper plant CFB boiler in Asia, Photo by Furnace Mineral Products Inc.

It is best practice to inspect the boiler tubes for metal loss from erosion during maintenance outages. This can be done by ultrasonic or visual inspection techniques. In general, erosion patterns appear as smooth and sometimes shiny locations on the tube. The use of a bright colored ceramic coating aids in the visual inspection for erosion of the boiler tubes. The inspection approach is easy - where you see the coating, no metal loss has taken place. Where the coating is missing these are areas that require additional monitoring and eventual coating repair. The use of an electronic coating thickness gauge allows for easy film thickness measurements to be taken quickly, mapped and tracked from outage to outage to obtain useful wear pattern data.

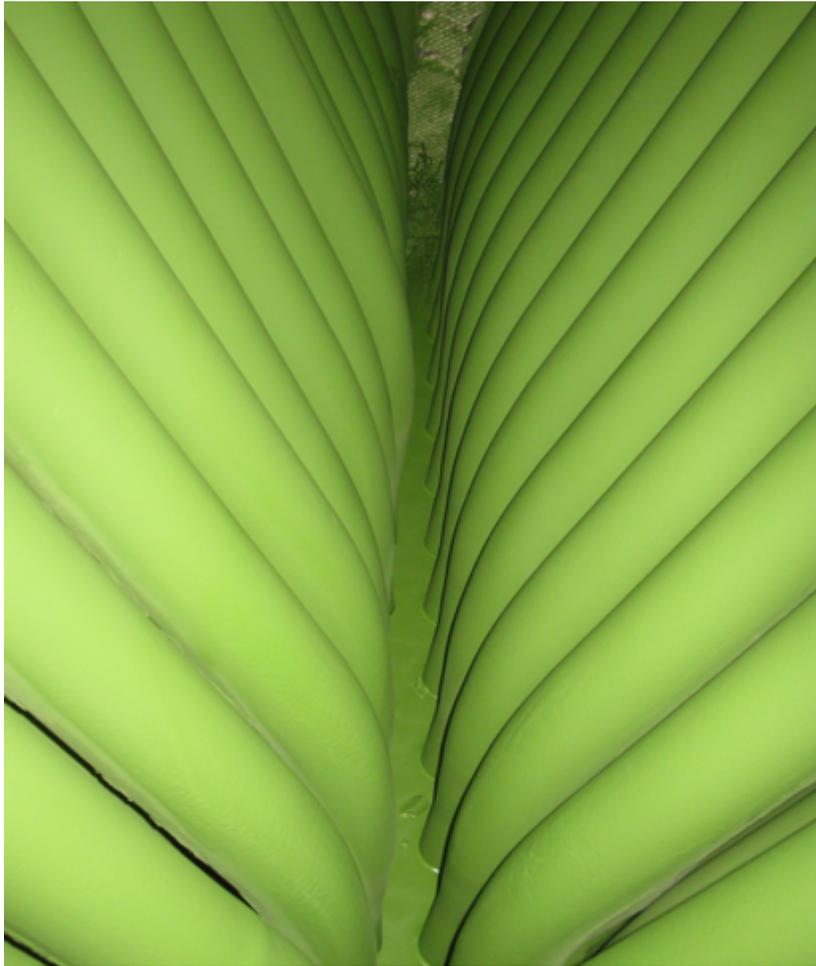
Ceramic coating used to protect hard to reach generating bank mud drum from fly ash erosion damage, Photo by Furnace Mineral Products Inc.
