**Case studies into the Performance and Benefits of Advanced Ceramic Coating Technologies for Corrosion, Erosion and Slagging Mitigation in Fossil Fuel Fired Power Generation Units.**

Antonio Liberatore  
Furnace Mineral Products Inc.  
37 Sandiford Drive, Suite 209  
Stouffville, ON L4A 7X5  
Canada

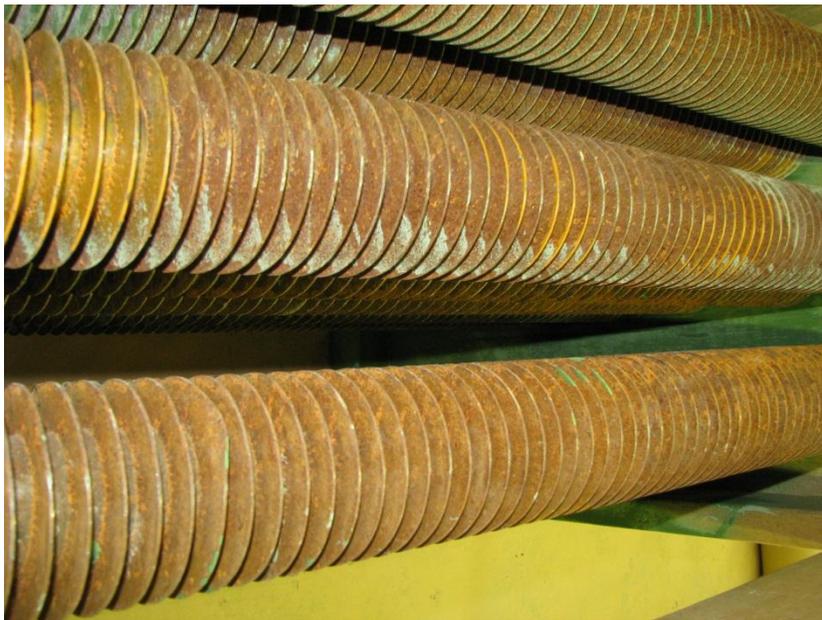
**Figure 9: Economizer prototype**

A prototype of the economizer was constructed in order to assist in the development of surface preparation and coating application techniques for the components and configuration specific to this economizer. Figure 9 illustrates the economizer prototype, economizer tube configuration and restricted access to surfaces of components.

Ceramic coating was applied to the economizer bundle in order to protect the finned tubes form erosion and extend the life expectancy of the assembly.

Ceramic Coating was successfully applied to the economizer bundle to a nominal thickness of 200  $\mu\text{m}$  (8 mils) during the fall of 2008. Figure 10 below shows a section of the coated economizer.
