In this issue we investigate
Super Heat Fouling

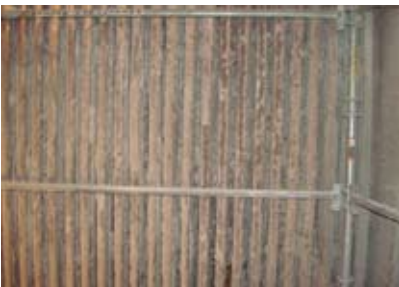
Before GreenShield

The Power Plant in this study has two pet coke fired circulating fluidized boilers (CFB) that use limestone injection for sulfur capture and removal. The superheat sections of each boiler would plug off with sulfated limestone agglomeration up to the point that the units had to be brought off line and cleaned. This was a very costly event often costing the company in excess of \$250,000 in lost revenue, contractor fees and employee overtime. Contractors and employees would spend a minimum of ten days in the units with hammers, rods and air lances cleaning the areas between the superheat tubes.

Under normal circumstances a clean superheat section will average a DP of 1.75 INWC and when they get dirty, it would go over 8 INWC.

To find a methodology that would allow the plant to operate without having to shut the boilers down once or twice a year to clean out the agglomeration. The solution was to take advantage of Green Shield's ability to prevent the initial sintering that leads to the agglomeration.

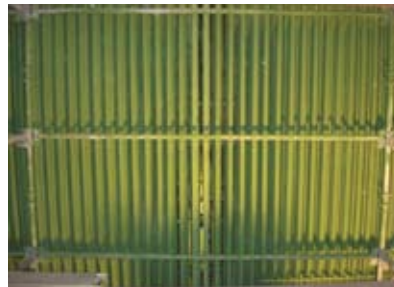
After GreenShield

The plant successfully operated for one year after the initial cleaning without any agglomeration issues at all. The ROI on the investment was 6 months. The DP across both boiler superheat sections never went above 2 INWC the entire operating year!

Another realized savings was the reduced amount of plant and contract labor needed to remove agglomeration during the annual outages. The agglomeration found on the superheat tubes during the first outage after the cleaning and coating was very soft and came off very easy with dead blow hammers. The amount of debris that was removed from the boilers the following year after the first application of the Green Shield was approximately 80% less than any of the previous years.
